## **Review and Measures for Rehabilitation of Zaingeer Canal and its Head Works**

### **Abstract**

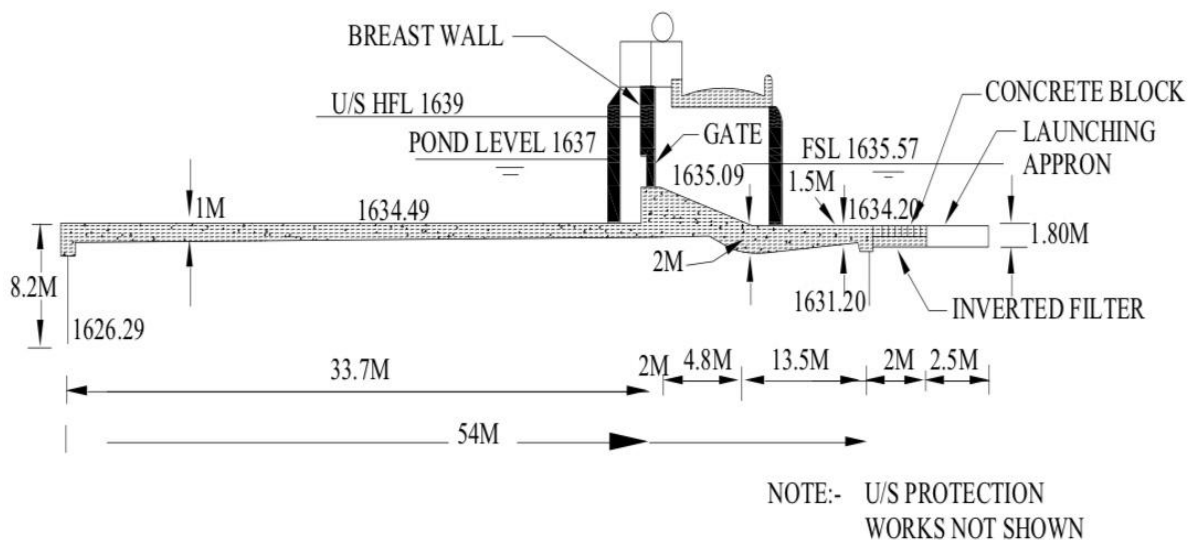
**Figure 4.1 Longitudinal Section of Head regulator**

The head works which is so important for a canal system, has almost become defunct and is just acting as a cut in the embankment of the Nallah allowing water into the canal without any proper regulation and restriction to the silt entry. So a need arises to renovate and improve the head works of the canal system. For this purpose it's proposed to design the head regulator afresh at the off take and also renovate the other components of head works like guide banks and river training works for the upstream and downstream of Madhumati Nallah near off take site.

**3.1.1 Design of Head Regulator for Zaingeer Canal at Sunnerwani Bandipore**

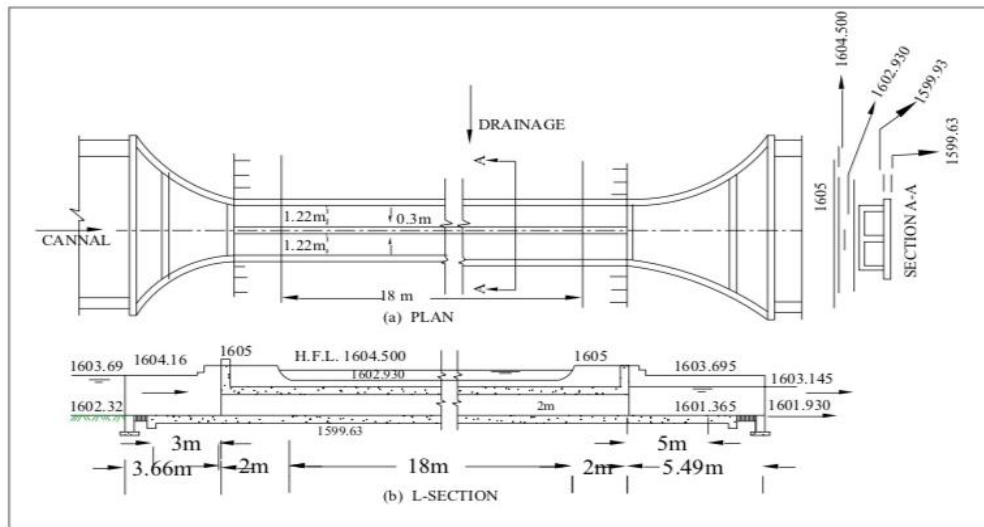
Figure 4.2 Plan and L-section of canal siphon at RD-17664 m

To prevent the canal from runoff/natural Nallah's from hilly areas, faulty canal syphons and aqueducts have been redesigned which are presently not functioning properly and catch water drains are to be constructed viz RD 335 to RD 1707, RD 3445 to RD 4176, RD 6400 to RD 88100, RD 15090 to RD 15900, RD 16850 to RD 17300, RD 19817 to RD 21345, RD 23018 to RD 23295, RD 25080 to RD 26830, RD 28090 to RD 29070, RD 29618 to RD 30137. The design of canal siphon at RD-17664 m and aqueduct at RD-4085 m are presented below.

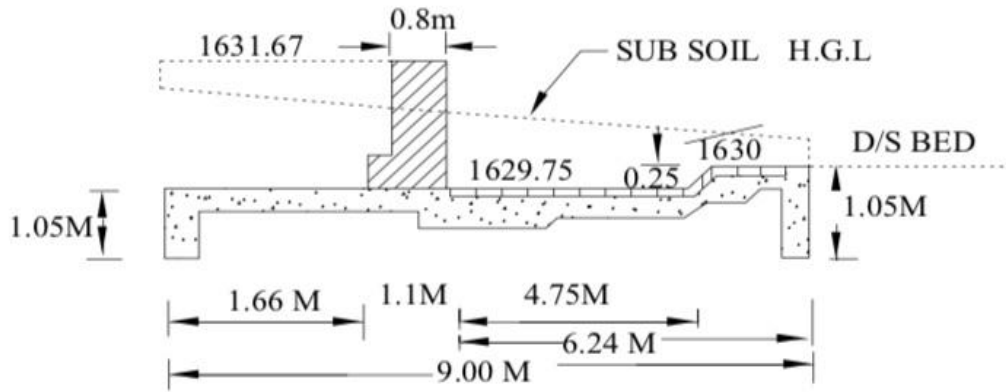
**Figure 4.5 Details of the floor**

The location of faulty Falls are RD 400m, RD500m, RD 564m, RD 612m, RD 648m, RD 700m, RD 796m, RD 884m, RD 952m, RD1050m, RD1300m, Rd 1378, Rd 1420m, RD 1492m, RD 1612m, RD 1872m, RD 3900m, Rd 26860m. The design of fall at RD-400m is presented below.

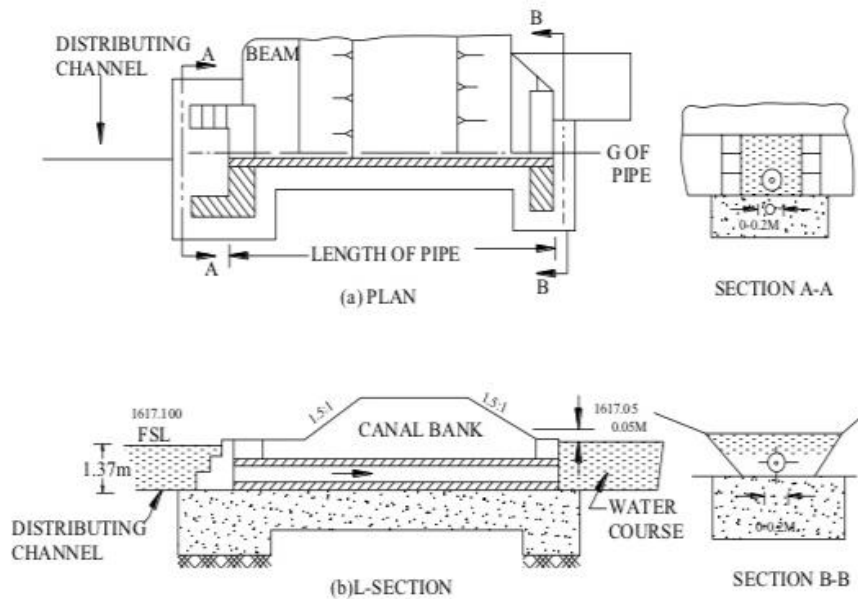
Figure 4.7 Plan and L-section of Outlet

All the canal outlets are defunct. The design of outlet at Panzigam Bandipore is presented below.
