A REVIEW ON SEISMIC PERFORMANCE OF MASONRY STRUCTURE DURING PAST EARTHQUAKES

Abstract — *The present work investigates the performance of masonry buildings during the most severe past earthquakes both national and international. The majority of the buildings in the affected region were built of masonry. The structure shows different types of damage pattern for low to severe earthquake conditions. Most of the masonry buildings were formed with random or coursed stone and mud brick walls without any reinforcement and confined masonry buildings. Many of these buildings were damaged or had collapsed. Generally three types of failure mechanism define the behaviour of masonry structures namely, sliding shear failure, diagonal shear failure and flexural failure. Confined and reinforced masonry buildings shows relatively good performance in comparison with other masonry buildings. The damages are due to several reasons such as poor construction quality and poor workmanship of the buildings. From the census in India majority (more than 80%) of the buildings is masonry. Thus the present study shows the need of retrofitting of masonry structures in India.*

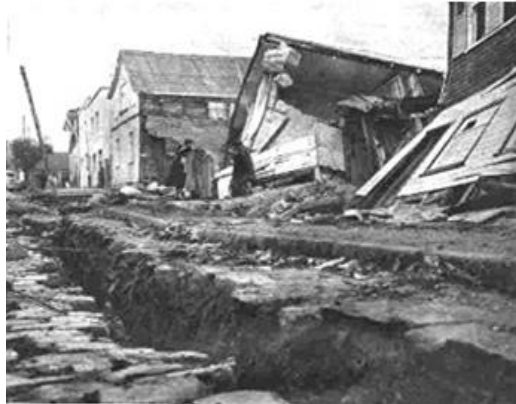
The earthquake shaking caused a wide range of damage to buildings within the affected area. The region has a lots of old houses, churches, and other buildings built with adobe or unreinforced masonry shown in Fig. 1. Absence of reinforcement and connection between adjoining walls resulted in the collapse of about 80,000 houses. Falling debris was a cause to many human deaths. About 300,000 houses and 400 churches were partially collapsed and unsafe to occupy. One of the historical buildings, Intendencia Regional del Maule, was severely damaged during the earthquake. The building was a three-story public historical building located in Talcal, Chile. The damage consisted of cracked and heavily compromise unreinforced masonry walls as well as interior and exterior architectural details and finishes. This was expected since old buildings such as the Intendencia Regional del Maule was not designed for the current earthquake knowledge.

Fig. 1 Partially collapse of the building in Valdivia Earthquake.

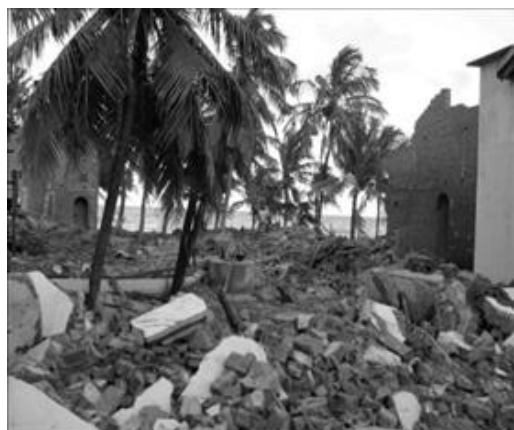
The Mw 9.0 earthquake struck at 06:28 a.m. local time in Sri Lanka. Although initial estimates had put the worldwide death toll at over 275,000 with thousands of others missing, according to the U.S. Geological Survey a total of 227,898 people died. While damage in little Andaman island and all Nicobar island was predominantly tsunami related, that in the islands north of little Andaman was primarily due to earthquake shaking, though tsunami waves and high tides were also an issue. In general, the building stock consists of a large number of traditional and non-engineered. Many traditional structures were made of wood, and they performed well in the earthquake shaking. However, a number of new, poorly constructed masonry structures suffered severe damage or even collapse due to shaking as shown in Fig 2.

Fig. 2 Total collapse of the building in Sumatra Earthquake

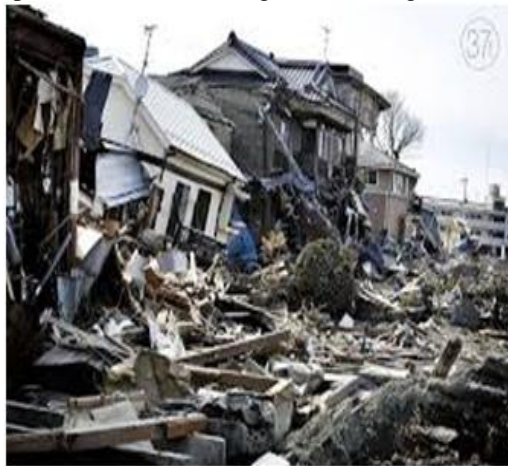
Fig.3 Pounding failure in Tohoku Earthquake

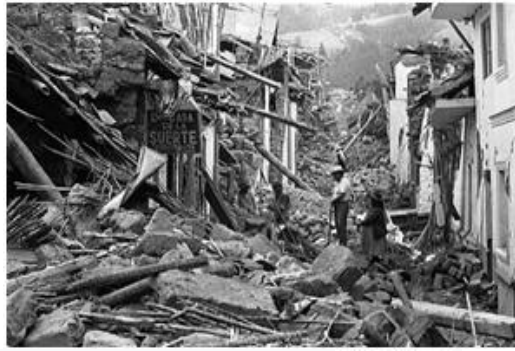
The Kamchatka Tsunami was generated by a magnitude 9.0 earthquake on November 4, 1952, in East Russia. The local tsunami, which generated waves as high as 50 feet, caused extensive damage to the Kamchatka Peninsula and the Kuril Islands, and left an estimated 10,000 to 15,000 people dead. Waves traveled as far as Peru, Chile and New Zealand, but the largest damage to other areas of the Pacific Ocean occurred in the Hawaiian Islands. Masonry structures were also widely distributed across this region even though their numbers are less than wooden buildings. Buildings built with tuff stone called nobirustone (shiogama-stone) produced in the Shiogama City region of Miyagi Prefecture were widely distributed across the Tohoku region and observed full collapse of the building in Fig 4.

Fig.4 Total collapse of the building in Kamchatka Earthquake.

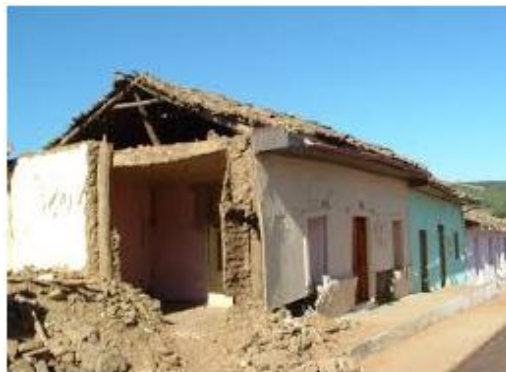
Museums, churches, and other historic masonry structures sustained out-of-plane failures in unreinforced masonry walls (Fig. 5), cladding damage, and parapet and other roof connection failures. For example, the Basilica Del Salvador in Santiago, constructed in the 1870s and previously damaged in the 1985 earthquake, was further compromised in the 2010 event. The building's façade lay in rubble at its base. Also in Santiago, large pieces of the façade on the west side of the museum of fine arts had fallen, damaging the stairs below. Throughout central Chile, historical churches were disproportionately impacted by the event, as most were unreinforced masonry or adobe structures and particularly susceptible to earthquake damage. In Curico, a church's tower had collapsed onto the roof, causing the roof to collapse as well. All that remained of a church in Peralillo were two stark white columns.

Fig. 5 Out of plane failure in Maule Earthquake.

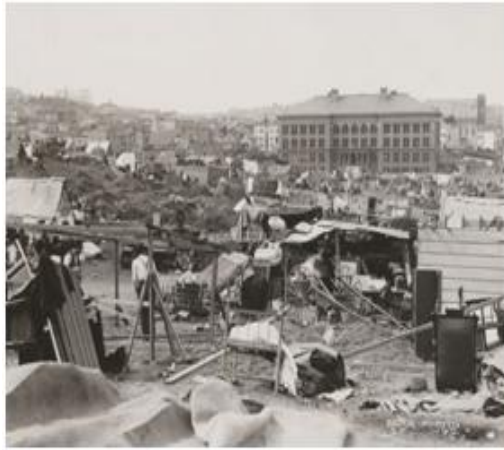
Fig. 6 Partially collapse of the building in Ecuador–Colombia Earthquake.

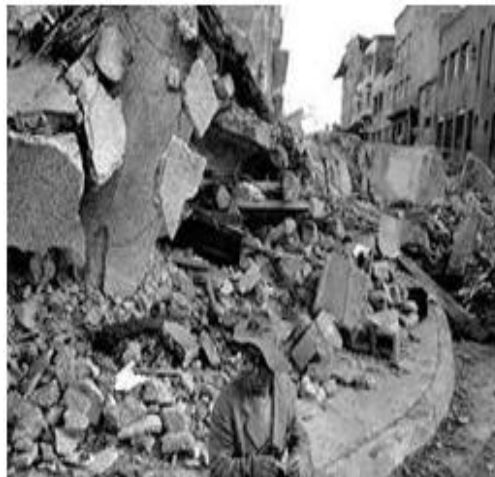
Loss caused by flooding on Amchitka Island was estimated at about \$10,000. Property damage was estimated at about \$311 million, collapse of building as shown in Fig 7.

Fig. 7 Total collapse of the building in Rat Islands

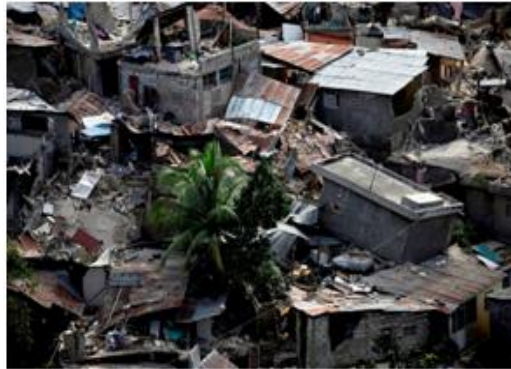
Fig. 8 Partially collapsed of the building in Assam-Tibet Earthquake.

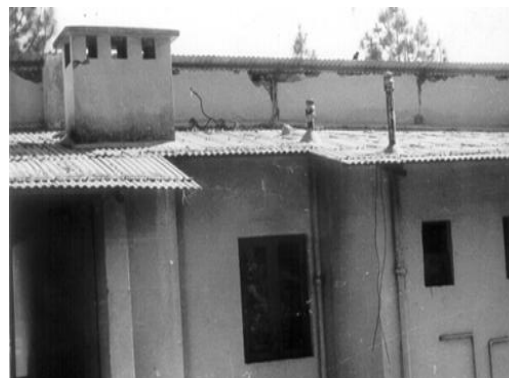
Uttarkashi has a number of three and four story reinforced concrete (RC) framed buildings which sustained damage. Shear-cracks developed in the ground floor columns of two stories Post Office Building in Uttarkashi built in 1985-86 by engineers of the department of post and telegraphs. The strong floor beams in the frame forced the yielding into ground-story columns. The weaker roof beams sustain flexural hairline cracks while the supporting second story columns were damaged. Most government buildings, both offices and residences, are one or two story buildings with load bearing walls and sloping roofs. Older construction was of unreinforced random rubble stone masonry which performed very poorly and observed full structures were collapse. The newer construction was of unreinforced concrete block masonry and usually includes a RC band at lintel level. The ITBP Paramilitary Campus at Mahidanda consists a large number of two story residential buildings with load bearing walls of concrete masonry. All have RC lintel bands, but no roof bands or gable bands. The construction was about 10 years old. The damage to buildings consisted of (i) diagonal cracks below window sills, (ii) damage at the connection between masonry walls and RC roof slabs, (iii) in buildings with corrugated iron sheet roofs, damage at seat of purlins on the gable end walls, and (iv) damage to walls supporting roofs at different heights at either end (Fig. 9).

Fig. 9 Damage to wall supporting Split Level roof - ITBP campus, Mahidanda, Uttarkashi Earthquake

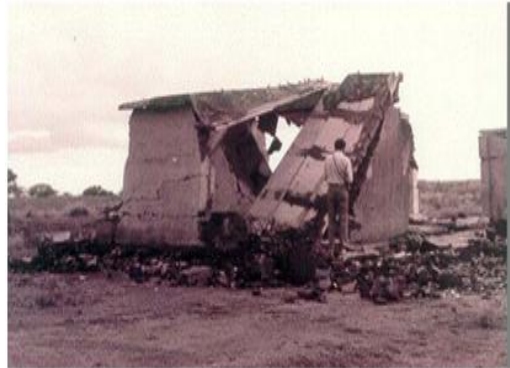
The collapse of traditional stone-and-mud buildings in the mesoseismal area was nearly total. The wood-plank roofs of these single-story dwellings typically are topped with a 30-60 cm thick layer of clay to provide protection from rain and heat. All such constructions behaved very poorly due to the heavy mass at the roof and the poor strength of the supporting rubble masonry walls; such houses were the main cause for the high number of casualties as shown in Fig 10.

Fig. 10 Collapse of brick masonry structure in Killari Earthquake

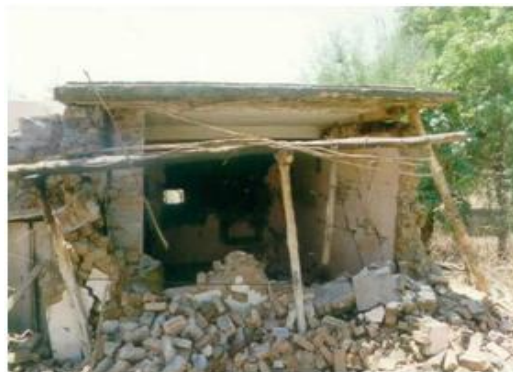
Fig. 11 Partially collapsed of the structure in Jabalpur Earthquake

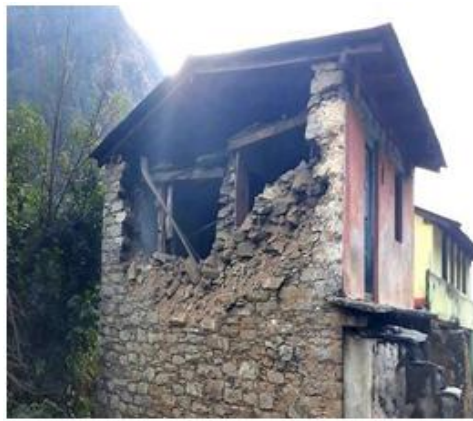
Fig.12 Out-of-plane failure in Chamoli Earthquake

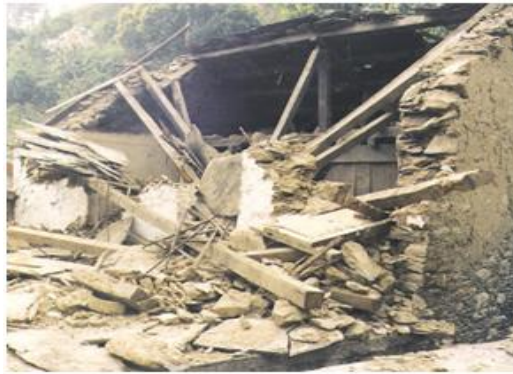
The most common damage type was partial collapse of load bearing walls due to “out of plane” behaviour (Fig. 13). Even if load bearing walls could stand after earthquake without total or partial collapse, wide cracks prevents usability of the buildings. Building types will be classified in terms of construction material, although, most of the buildings were constructed with binary combination of different materials.

Fig.13 Partially collapsed structure in Basyurt-Karakocan (Elazig) Earthquake

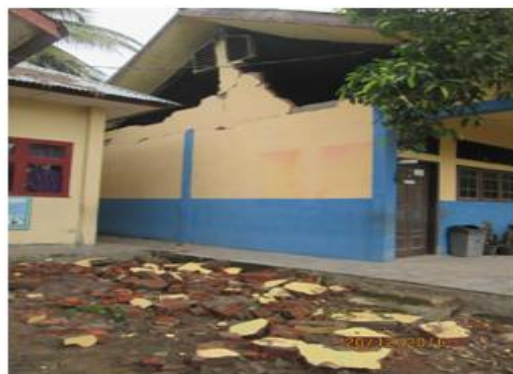
Fig.14 Collapsed masonry building in Pidie Jaya Earthquake

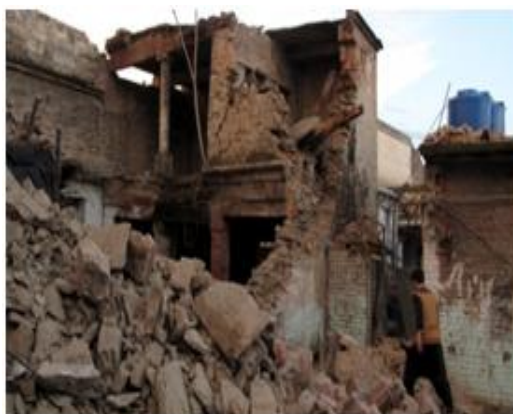
Fig.15 Partially collapsed structure in Afghanistan–Pakistan Earthquake

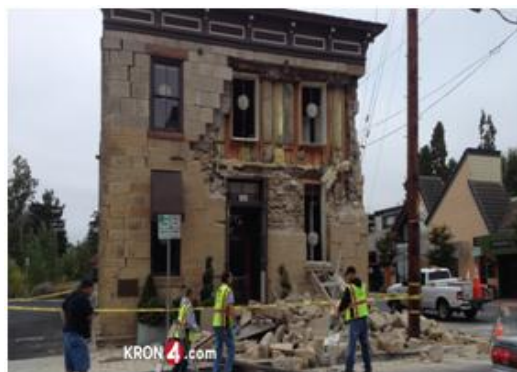
The housing stock in Napa and Solano Counties comprises mostly single family homes. Of the 207,000 housing units in the region, over two-thirds were detached single family units (masonry structures). In Napa County, nearly 30% of the housing stock was built before 1959, while in Solano County only 20% of residences predate 1959. The median house price in Napa County is \$460,000; in Solano County it is \$290,000. Napa County also observed that many failures occurred in structure like out-of-plane, in-plane, and pounding etc. as shown in Fig 16.

Fig.16 Out-of-plane failure in South Napa Earthquake

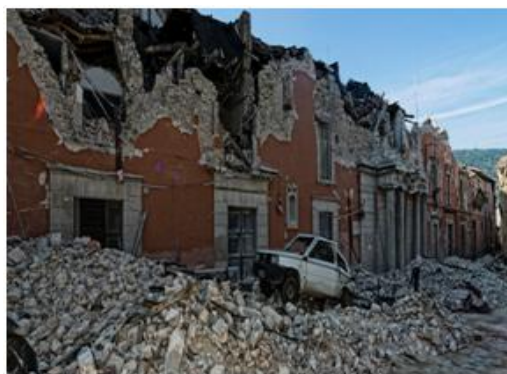
Better construction practices and, probably, lower ground shaking made older buildings perform relatively well, with many fewer collapses than more modern construction. Some significant examples of damage to older buildings include out-of-plane failures of walls and failure of the roof-supporting structure as shown in Fig 17.

Fig.17 Out of plane failure of building in Molise Earthquake

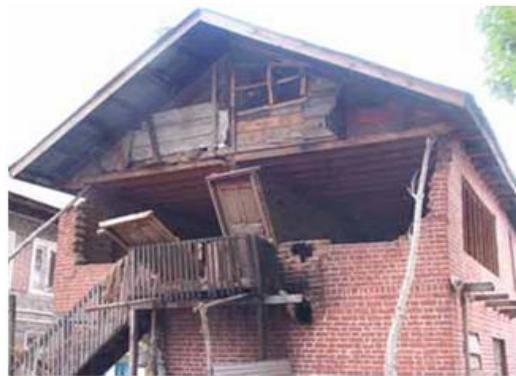
Fig.18 Out-of-plane collapse in Kashmir earthquake

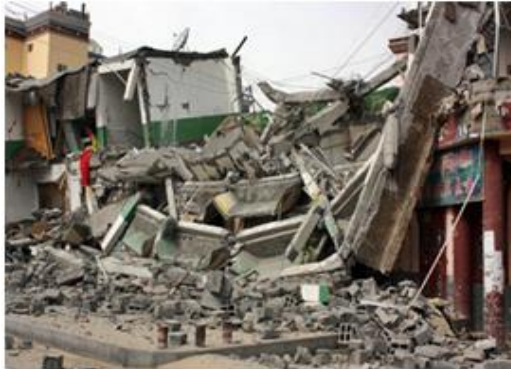
Fig.19 Fully collapsed of the structure in Lushan Earthquake

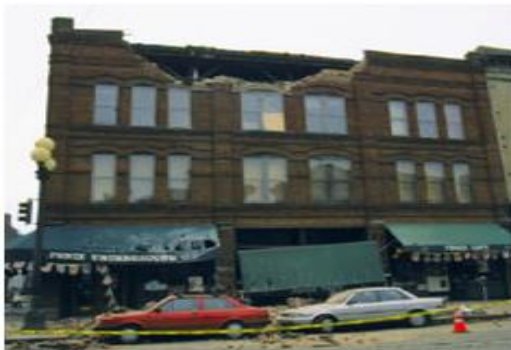
Structural and non-structural damage also resulted from geotechnical failures. In general, areas that sustained the most significant damage were built on fill or weak soils. Lateral spreading and settlement induced large deformations, which resulted in nonstructural and some structural damage. Landslides caused damage to houses. Unreinforced masonry (URM) buildings built before 1950 exhibited the poorest behaviour. The most common damage included shedding of brick from parapets and chimneys. Other URM buildings exhibited diagonal “stair-step” cracking in walls and piers, damage to walls in the upper stories, vertical cracking in walls, damage to masonry arches, and damage to walls as a result of pounding. In many cases, fallen brick resulted in damage to objects, such as cars and canopies, outside the building as shown in Fig 20.

Fig.20 Brick Parapet and Wall Failure in Nisqually Earthquake

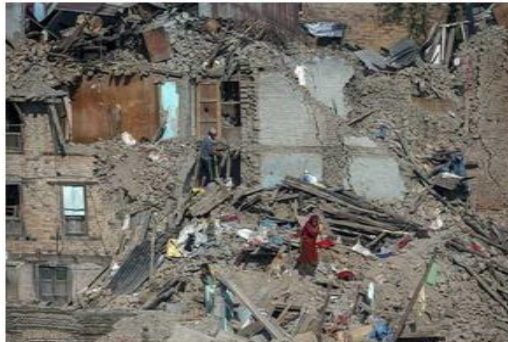
Most of the damaged masonry structures were poorly constructed without following the design guidelines while minor or no structural damages were observed in well-constructed masonry buildings. Several structural deficiencies by the recent earthquake were assessed including: poor quality of materials and workmanship, pounding effect, weak storey, unconfined gable walls, missing confining elements, vertical and horizontal irregularities, lack of corner treatment, heavy balcony and poor anchorage for horizontal projections (Fig. 21). Lack of cyclic maintenance and unpreparedness for strong ground shaking. The major deficiencies indicating non-compliance with codal provisions should be noted and strengthening of existing building may increase the performance of the building on coming days.

Fig. 21 Quality of mortar and bricks used in building in Nepal Earthquake
