## **Study on Flexural Strengthening of Corroded R.C Beam with Basalt Fiber Sheet**

**Abstract—** *The presents examination manages the conduct of bars having fluctuating levels of corrosion, for example, 5%, 10% and 15% mass losses of re-bar and the impact of Basalt fiber sheet wrapping on Beam its flexural behaviour. Aggregate of 78 beams examples will be casted which will include of 6 control examples. The control example will be of non-corroded in gathering of 3 each for review of M-20 and M-25. 36 beams will be casted with M-20. From 39beams gathering of 3 beams for 5%, 10% and 15% corrosion and its wrapping by 4 wrap pattern of basalt fiber sheet. Like 39 beams for M25 will be casted. Furthermore, result is contrasted and the compared with normal sample beam. Basalt fiber retrofitting with U-wrapping Pattern enhanced a definitive load conveying limit and flexural Strength of corroded beams altogether high than another wrapping design.*

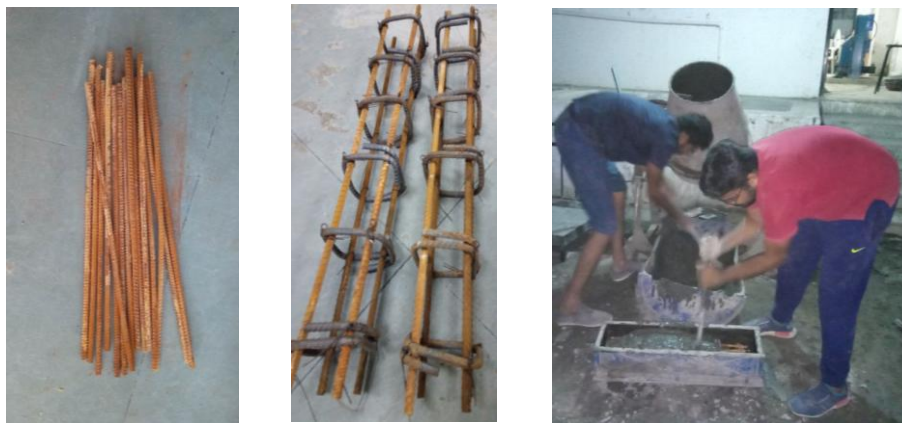
*Fig. 2 Re-bar and Beam Casting*

Aluminium shuttering is utilised for forming the beam. Appropriate greased is done on Aluminium shuttering for without difficulty removing the shuttering without damage the beam. Beams were reinforced as demonstrated in figure-2.

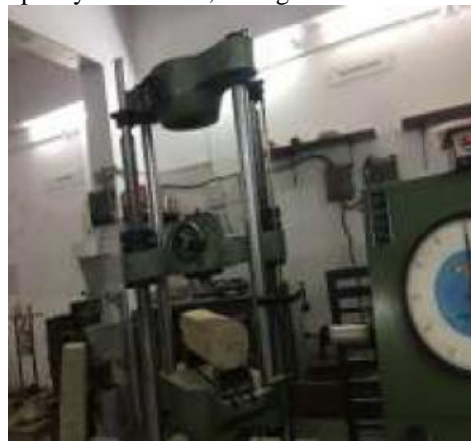
*Fig. 3 Beam Testing under (UTM).*

Beams are tested under UTM with capacity of 2000kN, arrangement is shown in Fig. 3.

As shown in Overhead figure the test arrangement of beams. It contains of hydraulic jack through weight is applied on beams, the beam is put over the steel rollers to support the beam.

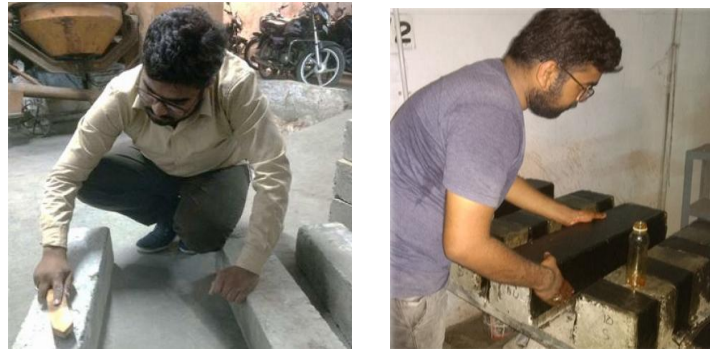
Fig. 5 Surface Preparation and Applying Basalt fiber on Beam.

Hand lay-up methodology is employed for Strengthening of beams. The surface of the beam once rough with steel Wire brush then cleansed with water to get rid of all dirt's for the right bonding with fibre sheets.

A layer of epoxy and Harder 2:1) is applied at an acceptable thickness of regarding one millimetre with help of brush. The basalt fiber sheets were measured and move the required form and dimensions.

The basalt Fiber sheet were placed on surface of beam and lightly pressed onto the coated synthetic resin.

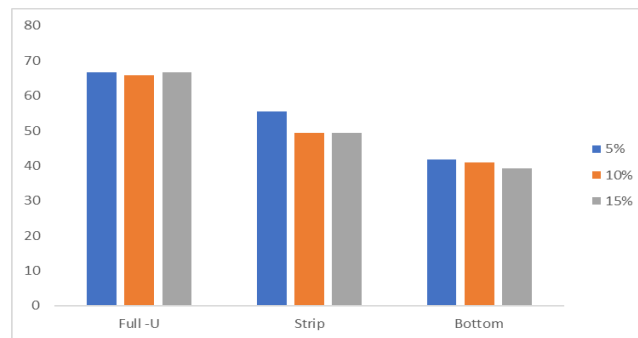
Fig. 5 Strength Increases of Retrofitted beam for M-20

Sr No	Wrapping pattern	Avg. Strength in (N/mm <sup>2</sup> )		
		5%	10%	15%
1	Full -U	66.63	65.82	66.75
2	Strip	55.46	49.35	49.26
3	Bottom	41.72	40.88	39.19

Retrofitting of beam specimens with basalt fiber sheet in U- Wrapping pattern enhance a flexural Strength and ultimate load carrying capacity of corroded beam specimens are high than another wrapping pattern. For both grade of concrete (M-20 and M-25) and different rate of corroded beams (5%, 10%, and 15%).

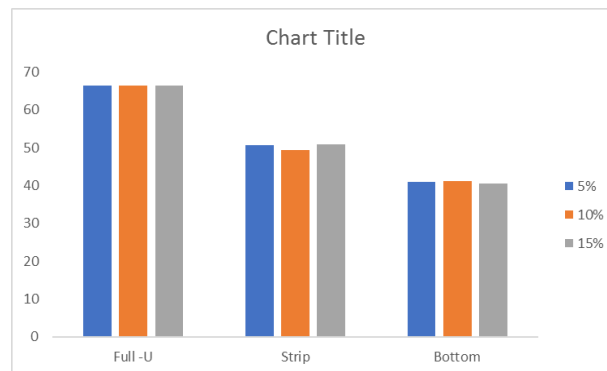
Fig. 6 Strength Increases of Retrofitted beam for M-25

Sr No	Wrap- pattern	Avg. Strength (N/mm <sup>2</sup> )		
		5%	10%	15%
1	Full -U	66.42	66.33	66.46
2	Strip	50.54	49.27	50.89
3	Bottom	40.90	41.20	40.50
