COMPREHENSIVE STUDY ON VARIOUS CHALLENGES ENCOUNTERED DURING THE CONSTRUCTION OF THE THREE GORGES DAM AND THEIR MITIGATION

Arsalan Farooq

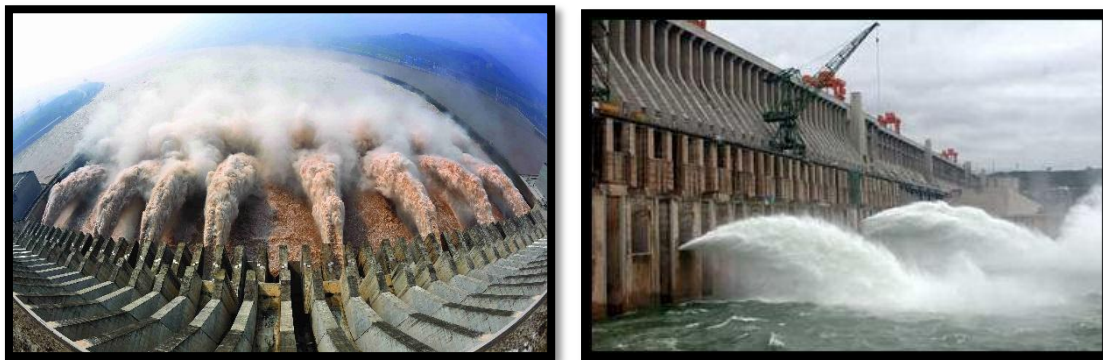
2.3: Damage by floods: The Three Gorges Dam holds large volume of water behind. During the floods it has a capacity to hold 22 billion cubic meter of water. If this water is released it can cause dam failure. This issue has also been addressed. Water is released in controlled manner through system of 46 go away gates and chutes. The spillway is designed to deal with water force as it drops from the height of 100m. It achieves huge velocity at the bottom of the dam. To deflect the force of water crashing down, engineers used technology similar to Grand Coulee dam. As the water level rises engineers open a series of gates to drain the flood water from the reservoir. If water falls straight it could undermine the foundation of the dam. So the engineers filled gates with concrete to form a ramp. The Three Gorges Dam ramps are above the water level. Water is hurled into the air. Once airborne the water breaks up into small droplets and losses much of its destructive energy. It lands over 100m downstream where it cannot do any damage.

Fig 3: Removal of excess water during floods

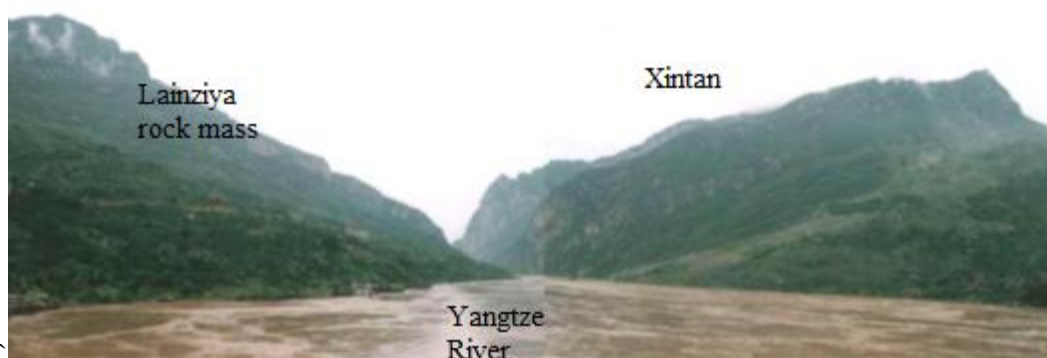
2.5. Landslide: The area surrounding the dam is prone to landslides. Raising and lowering of water in the dam reservoir intensifies this effect. Lainziya rock mass and Xintan landslide are situated on the banks of Yangtze River 16 miles upstream of dam. These are responsible for landslides of great devastation. At least 14 old landslides are considered likely to be reactivated by the filling of the reservoir. In order to monitor the landslides, 4 corner reflectors have been installed on the Xintan landslide slope and 6 on the Lianziya hazardous rock mountain. These reflectors are connected to INSAR. The banks are also strengthened with concrete.

Fig 5: Landslide prone area along Yangtze River
