## **DAMAGE INDICES OF FLOOD DAMAGED BUILDINGS IN PULWAMA DISTRICT OF KASHMIR VALLEY**

Suhail Ahmad Ahanger

Department of Civil engineering, Islamic University of Science and Technology Awantipora, J&K

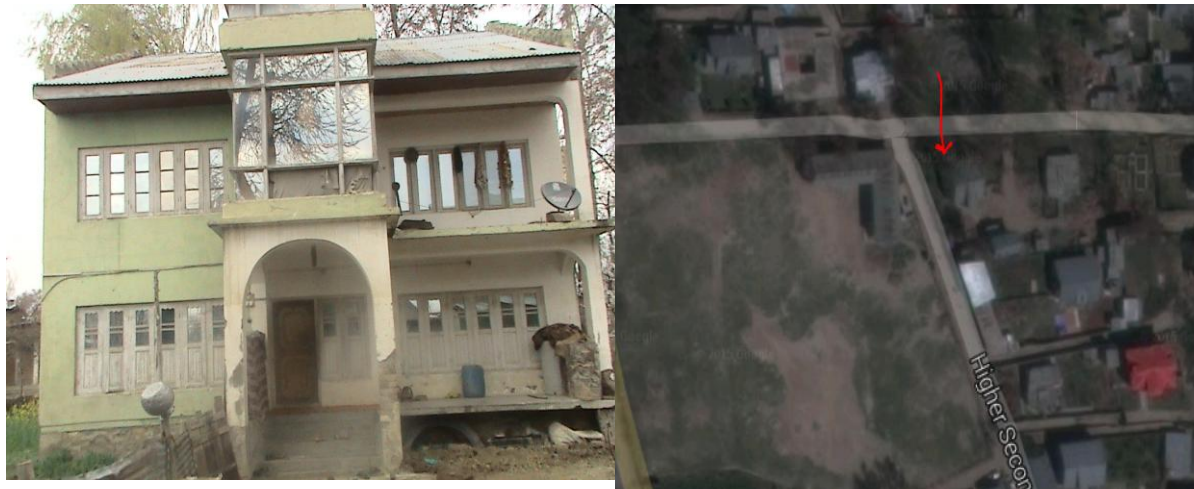
Distance of house from Jhelum bank	237.18m
Direction through which water entered the house	North side
Nature of flow	Highly turbulent
Height of water column above plinth	10 ft
No. of storeys	2
Material used in the structure	Bricks with mud mortar
Type of structure	Load bearing
Wall thickness	13"
Height of plinth	2.5 ft
Height of building	20.5 ft
Size of openings	Door(3'×6') windows (5'×4')
Age of structure	25 years

*Figure 2: photograph of building (left) and the location of the building on the google map*

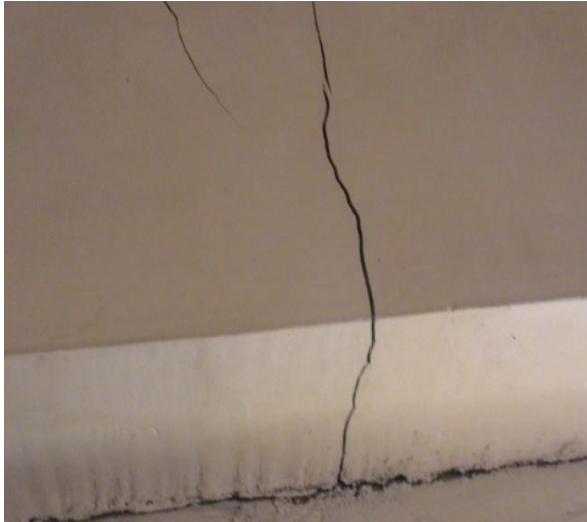
**DAMAGE IN BUILDING 1 :** The damage in the building has been studied exclusively for the calculation of damage index. The building has cracks distributed widely in ground floor as well as in first floor .The cracks in the buildings range from G1 to G5 (IS 13935:2000).The ground floor has four predominant cracks.Crack 1( G2 ) is a vertical crack present in the wall of the room of ground story. Crack 2(G2) is the crack present in the interface of door and wall and is also a vertical crack .Crack 3 (G5) is diagonal crack present in the load bearing wall of first floor .Similarly crack4 (G2) is the crack present in the lintel level of first floor Since the building is load bearing structure there were no beams and columns present in the structure. Also the floor of the building consist of wooden floor and there was no concrete slab present in the building. Crack 5 (G4) is the diagonal crack present in the walls of first floor and crack 6(G2) is the crack present at the floor level of the ground floor.

Figure 3: Crack 1 ( Ground Floor)

DAMAGE	TYPE OF DAMAGE	FLOOR LEVEL	MATERIAL OF THE BUILDING	LOCATION OF THE DAMAGE	AGE OF THE BUILDING	Damage Index
<b>Overall weightage Factor</b>	<b>(1)</b>	<b>(0.7)</b>	<b>(0.9)</b>	<b>(0.9)</b>	<b>(0.7)</b>	
CRACK 1	0.6	1	1	0.9	0.7	$(1 \times 0.6) \times (0.7 \times 1) \times (0.9 \times 1) \times (0.9 \times 0.9) \times (0.7 \times 0.7) = \mathbf{0.150}$
CRACK 2	0.6	1	1	0.8	0.7	$(1 \times 0.6) \times (0.7 \times 1) \times (0.9 \times 1) \times (0.9 \times 0.8) \times (0.7 \times 0.7) = \mathbf{0.133}$
CRACK 3	1	0.9	1	0.9	0.7	$(1 \times 1) \times (0.7 \times 0.9) \times (0.9 \times 1) \times (0.9 \times 0.9) \times (0.7 \times 0.7) = \mathbf{0.225}$
CRACK 4	0.6	0.9	1	0.8	0.7	$(1 \times 0.6) \times (0.7 \times 0.9) \times (0.9 \times 1) \times (0.9 \times 0.8) \times (0.7 \times 0.7) = \mathbf{0.120}$
CRACK 5	0.9	0.9	1	0.9	0.7	$(0.9 \times 1) \times (0.7 \times 0.9) \times (0.9 \times 1) \times (0.9 \times 0.9) \times (0.7 \times 0.7) = \mathbf{0.202}$

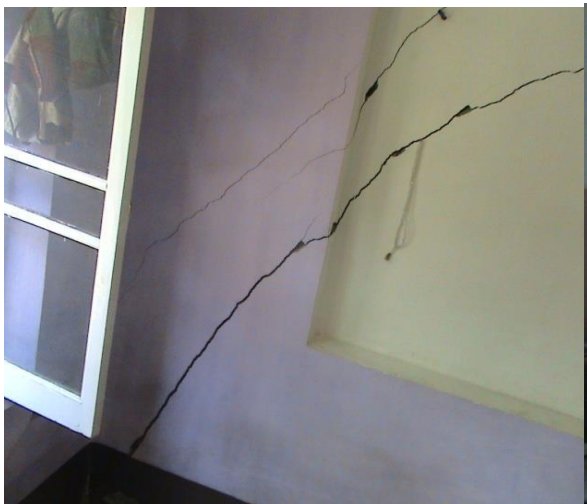
Figure 7: Crack 4( first Floor)

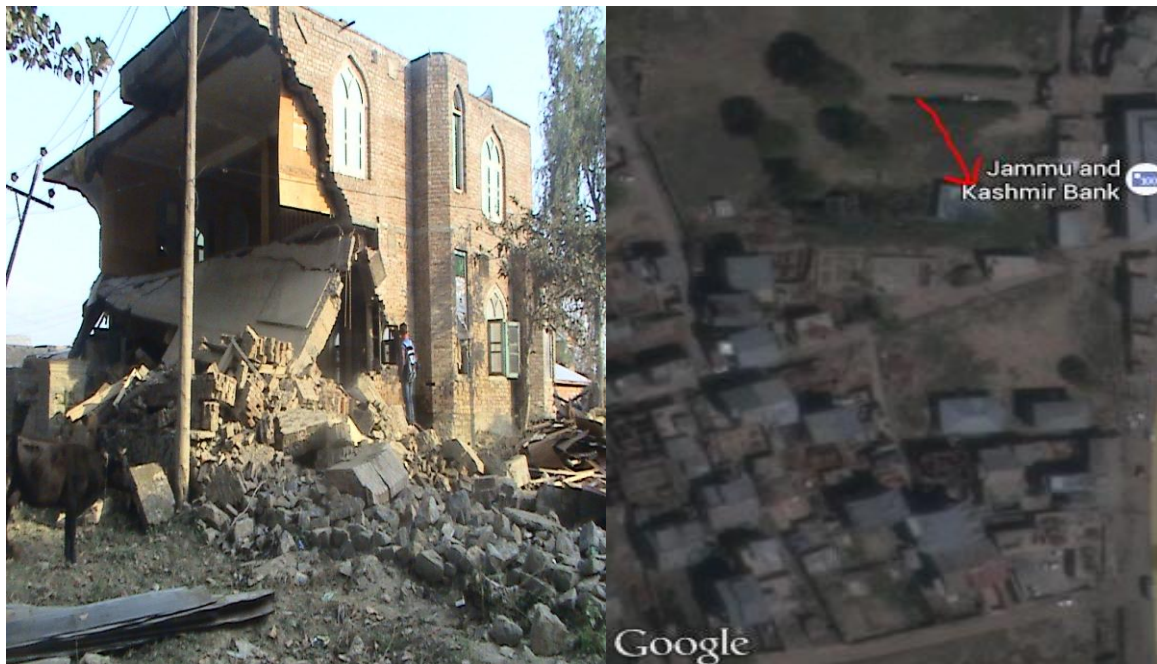
Distance of mosque from Jhelum bank	152.44m
Direction through which water entered the house	North side
Nature of flow	Highly turbulent
Height of water column above plinth	6 ft
No. of storeys	2
Material used in the structure	Cement concrete
Type of structure	Framed structure
Wall thickness	13”
Height of plinth	3 ft
Height of building	20 ft
Size of openings	Door(5’×7’) windows (3’×4’)
Age of structure	10 years

*Figure 9: Photograph of building 2 (left) and its location of the building on google map*

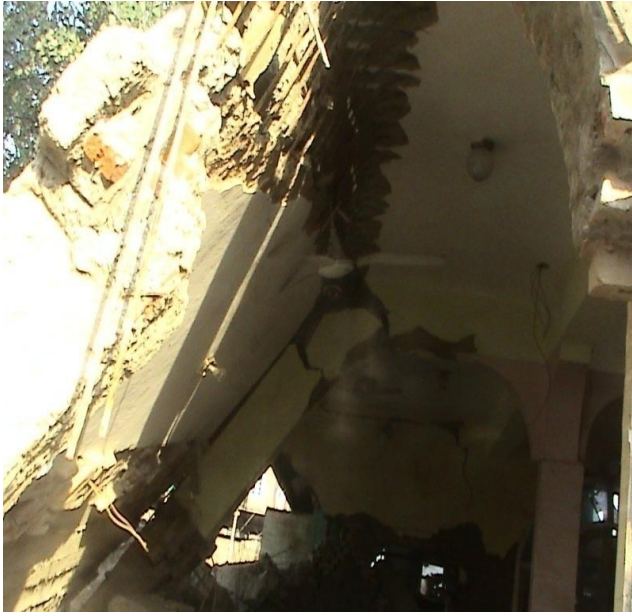
Figure 10: Damage 1

Due to the high turbulence of the water one of the walls of the structure was completely raised to the ground .Since the wall was sandwiched between beams and columns and hence beams and columns also failed ( figure 10).The complete failure of the wall forced the beams and slab to come down and hence a portion of the slab came down.The infill brick masonry also developed diagonal cracks ( Figure 11 ) of type G4.The beams of the building suffered heavy damage and the damage type exceeded G5( figure 12).The brick work of first storey was completely damaged (figure 13).The lintel of the ground floor suffered the cracks of type G5.The beam column junction of the ground floor suffered massive damage and the junction reinforcement came out . .

DAMAGE	TYPE OF DAMAGE	FLOOR LEVEL	MATERIAL OF THE BUILDING	LOCATION OF THE DAMAGE	AGE OF THE BUILDING	Damage Index
<b>Overall weightage Factor</b>	<b>(1)</b>	<b>(0.7)</b>	<b>(0.9)</b>	<b>(0.9)</b>	<b>(0.7)</b>	
Damage 1	1	1	0.8	1	0.6	$(1 \times 1) \times (0.7 \times 1) \times (0.9 \times 0.8) \times (0.9 \times 1) \times (0.7 \times 0.6) = \mathbf{0.190}$
Damage 2	0.9	1	0.8	0.9	0.6	$(1 \times 0.9) \times (0.7 \times 1) \times (0.9 \times 0.8) \times (0.9 \times 0.9) \times (0.7 \times 0.6) = \mathbf{0.154}$
Damage 3	1	1	0.8	1	0.6	$(1 \times 1) \times (0.7 \times 1) \times (0.9 \times 0.8) \times (0.9 \times 1) \times (0.7 \times 0.6) = \mathbf{0.190}$
Damage 4	1	0.9	0.8	0.9	0.6	$(1 \times 1) \times (0.7 \times 0.9) \times (0.9 \times 0.8) \times (0.9 \times 0.9) \times (0.7 \times 0.6) = \mathbf{0.154}$
Damage 5	1	0.9	0.8	0.8	0.6	$(1 \times 1) \times (0.7 \times 0.9) \times (0.9 \times 0.8) \times (0.9 \times 0.8) \times (0.7 \times 0.6) = \mathbf{0.137}$

The damage index of the building 1 is **0.963** and that of building 2 is **1.015**. From the damage index values it can be inferred that the building 2 has suffered more damage than building 1. The height of the water column above the plinth is 6ft in building 2 while as the height of water column above plinth is 10 ft in building 1. The reason for maximum damage in building 2 inspite of having less height of water column is attributed to hydrodynamic and impact loads, while as in case of building 1 the damage is attributed to hydrostatic action of flood water. The damage index of large number of buildings can be calculated by the same procedure and then correlation between height of the water column and damage index can be drawn. From the above studies it can be also inferred that the building 1 has scope of retrofit or repair as compared to building 2 which has no scope for repair or retrofit.
