MECHANALYSIS OF LEAKAGES IN FIN-TUBE TYPE RADIATOR

Bhavin R. Patel¹, Dr. Vina D. Chauhan², Dhara P. Trivedi³, Sunil D. Kininge⁴

Mechanical Engineering Department, Birla Vishvakarma Mahavidyalaya Engineering College, Vallabh Vidyanagar – 388120, Gujarat, India

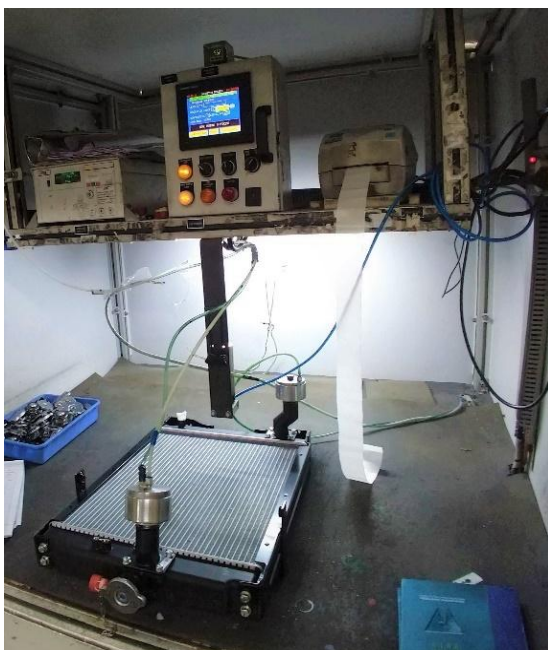
Dry leakage test and wet leakage test is conducted for identification of leakage. Visual inspection also carried out for identification of leakage. Dry leakage test is pneumatic test carried out by pressure of air. It is fast testing method; low-cost and non-corrosive substance are in contact with radiator due to this reason it is most preferable method for leakage testing of radiator. Primary advantage of dry leakage testing is speed in leakage testing at higher accuracy.

Figure 2 Dry leak test

Wet leak test is used to identify location of leakage in leak radiator identified by dry leak test. It is based on the technique of submerging the part in the water that is stored in an immersion tank. Fig. 2 & fig. 3 shows testing setup of dry leak test and wet leak test.

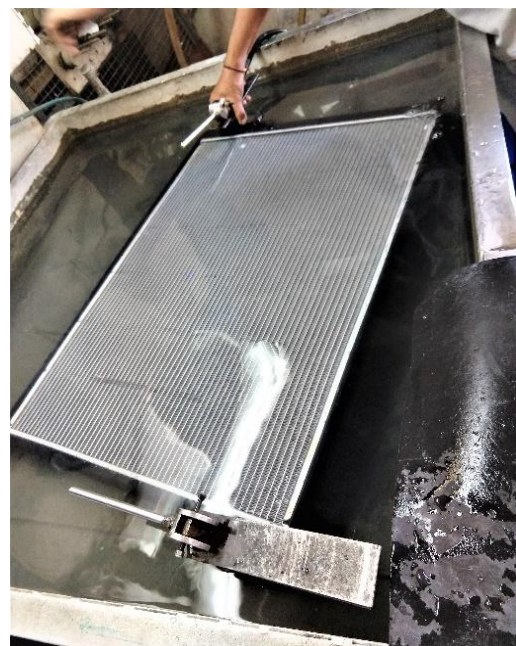
Figure 3 Wet leak test

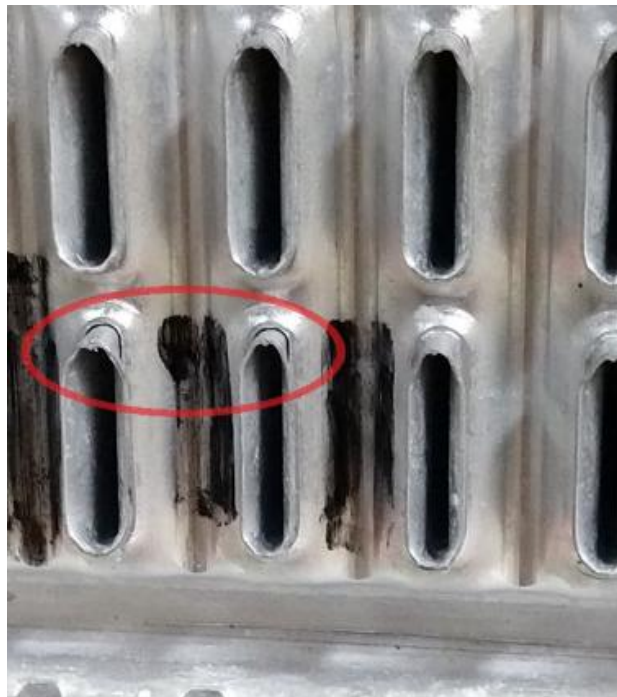
Various types of defects are identified in radiator from which header plate to tube joint leakage is higher as compare to other defects. So that further analysis is carried out on header plate to tube joint leakage to analyse the cause of leak.

Figure 4 Header plate to tube joint leakage

In brazing process, if header plate to tube joint is not brazed properly than this type of leakage is occur in radiator. If leakage is identified at furnace after completing brazing process than it will re-brazed to resolve leakage. If it will be left or visually not identified than it will identified at dry leakage test.

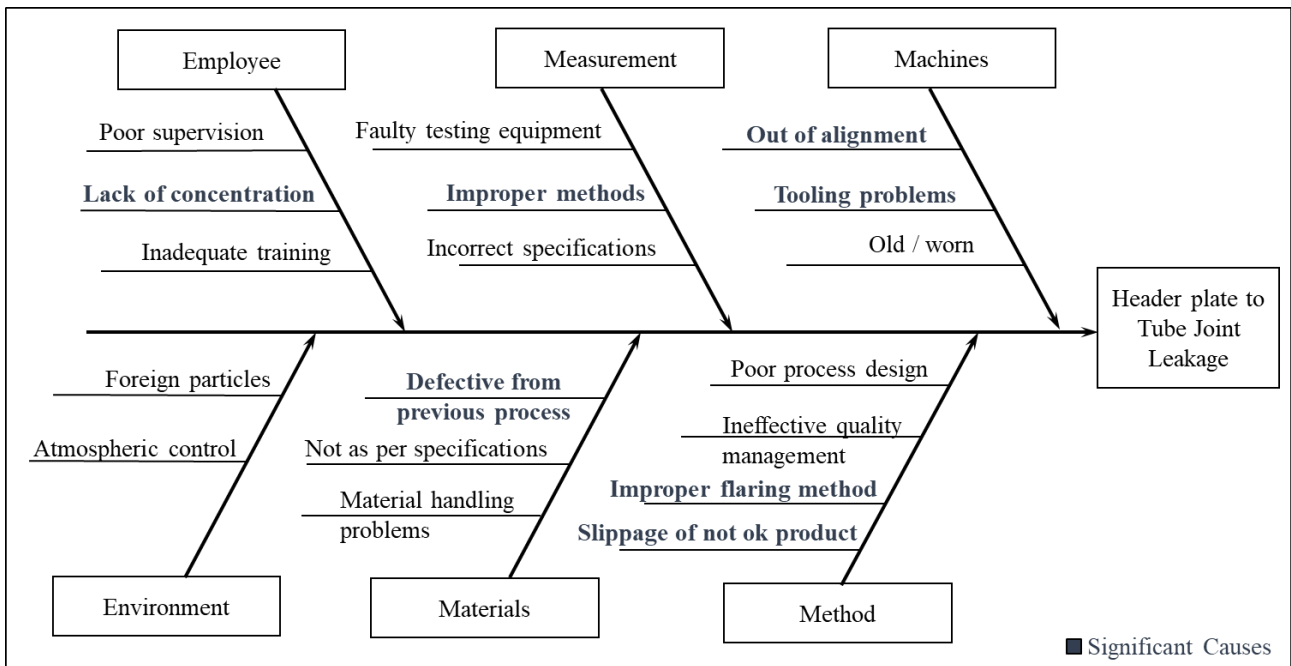
Main sources are elaborated from cause-effect diagram to discretise causes of header plate to tube joint leakage. Sources of variation are divided in sub categories to analyse cause effect diagram. Parameters relates with header plate to tube joint leakage are analysed in the cause-effect analysis.

Figure 5 Cause-effect diagram of header plate to tube joint leakage

Thickness of tube & header plate is different but if braze clad material of both the parts are same than it is more suitable for brazing joint due to melting temperature. Melting temperature difference of header plate and tube material needs to identify for brazing compatibility. The temperature is provided to radiator core by furnace is compared with design temperature of furnace for brazing to analyse the variation. If flux jam in furnace or heat loss occur in furnace than variation occur in temperature provided to core and design temperature which will cause discontinuities in joint. Temperature at every phase of furnace is observed and no variation found in it. Suitable brazing temperature of header plate and tube material is compared with design temperature and it is found ok.

Gap allowed between header plate and tube is 0.05 mm to 0.12 mm for braze joint fillet formation due to capillary action. Larger gap between header plate and tube reduces capillary action while smaller gap may restrict filler metal flow causing discontinuities in joint [8]. Gap is increased due to tube deformation so that flaring process is used to minimize the gap between header plate and tube.

After observing various models for leakage analysis, various possible causes of header plate to tube joint leakage are identified. Cause-effect diagram is used to analyse the parameters concern with header plate to tube joint leakage. Flaring of tubes after core assembly is needed due to deformation of shape in assembly operation. Causes concluded from leakage analysis are:

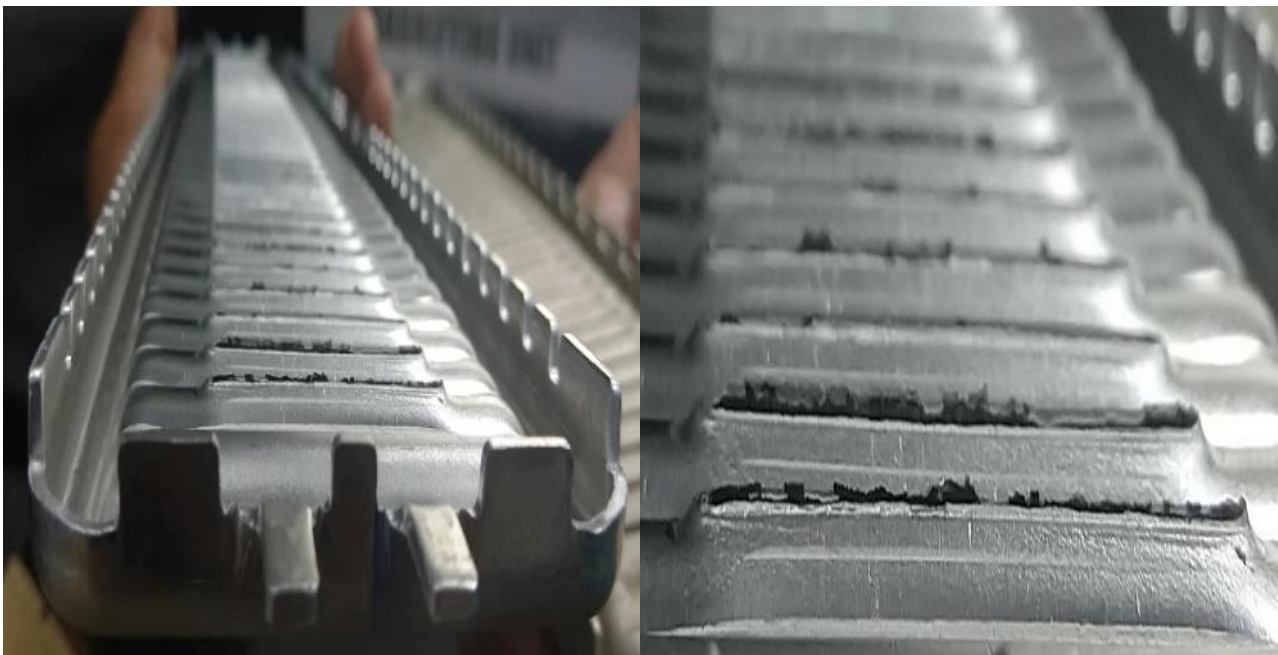
Header plate observed visually with the help of magnification glass and heavy burr found on slot of header plate. Heavy burr on slot profile of header plate shown in fig.6.

Figure 6 Heavy burrs on slots of header plate

Heavy burr visualised in visual inspection with the help of magnification glass on the slot profile of header plate. Slot profile analysis is conducted on profile projector and found that the heavy burr on slot profile can damage tube which causes header plate to tube joint leakage.

Radiators are tested for leakage detection by various leakage testing methods. Each method has different capacity of leakage detection and own significance. Some methods are not feasible for leakage detection of radiator due to many aspects i.e. time duration of inspection, economically, more precision required, safety factor, etc. Dimension of major axis and minor axis of slot in header plate are found acceptable in dimensional measurement. Tube dimension is also measured and found acceptable. No dimensional errors are found in dimension analysis so that dimensional error is not reason for header plate to tube joint leakage. In visual inspection, heavy burr found on slot profile can damage tube which causes header plate to tube joint leakage. Dents (rough surface) on slot profile are found in slot profile analysis conducted on profile projector to analyse the slot profile of header plate. It is found that the die used for slot punching operation is damaged and heavy burr occur on slot due to it.

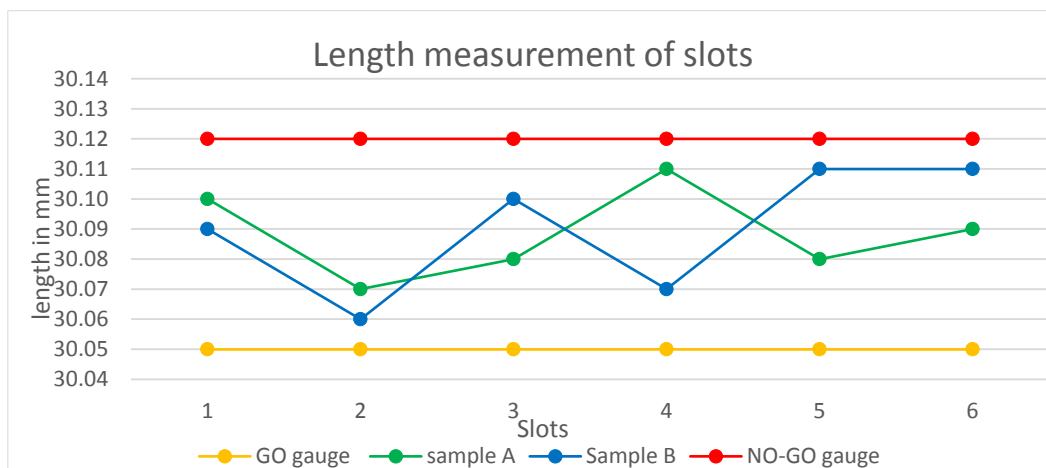
Figure 8 Length measurement of slots

Header plate to tube joint leakage is higher in radiator than other types of defects. Leakage is identified in radiator at wet leakage testing. So that header plate slots are measured. Length (major axis) of six slots of header plate are measured with Vernier calliper and inspected with go gauge and no-go gauge. After measurement and inspection, slot length is between 30.06 mm to 30.11 mm, it is found acceptable is shown in fig.8.

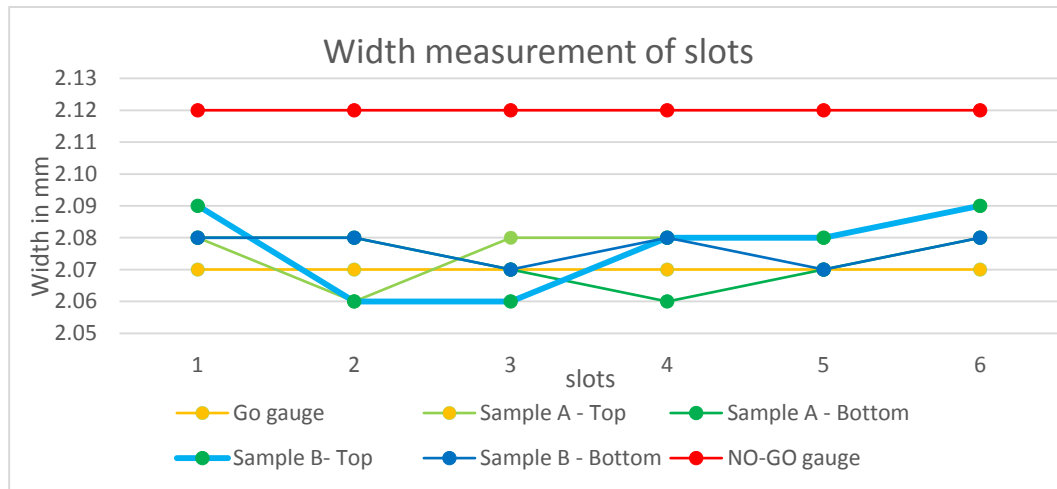
Figure 9 Width measurement of slots

Width (minor axis) of six slots of header plate are measured with Vernier calliper and inspected with go gauge and no-go gauge. After measurement and inspection, slot width is between 2.06 mm to 2.09 mm, it is found acceptable is shown in fig.9.
